## Marginal Summary

## Defective Summary

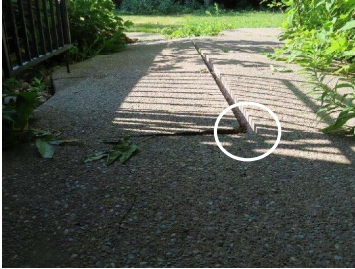
1. Walks: Concrete - **Walkway not level**

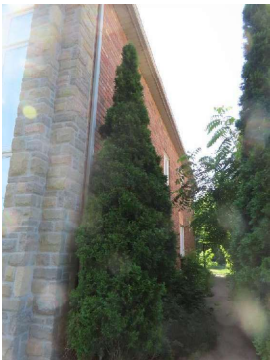
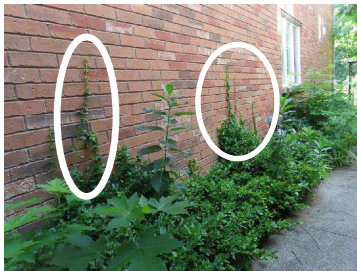
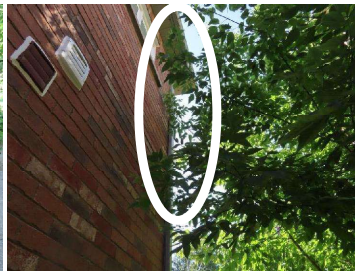
2. Vegetation: Trees - **Trees planted too close to structure, removal may be required, Tree limbs over hang the roof and should be cut back**

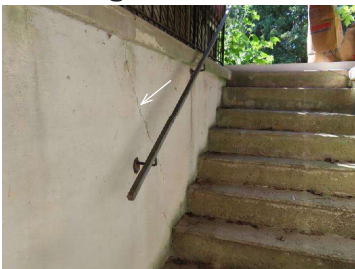
3. Retaining Walls: Concrete - **Wall cracked**

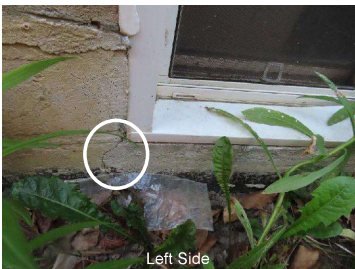
4. Main Exterior Surface Foundation: Pour concrete - **Minor crack**

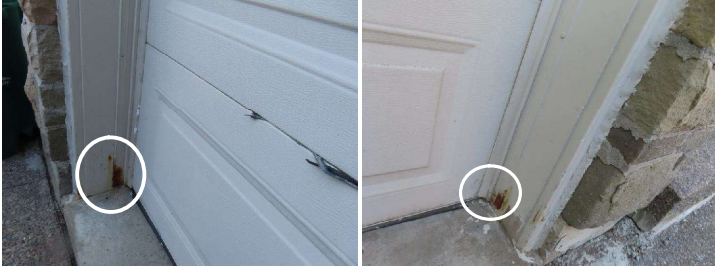
5. Front Garage Garage Doors: Insulated aluminum - **Door frame needs to paint**

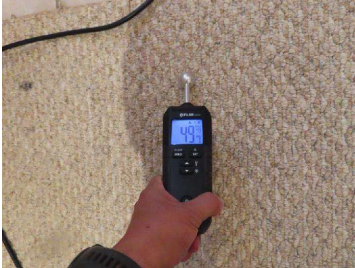
6. Main, Entertainment Room Basement Floor: Broadloom - **Water damaged**

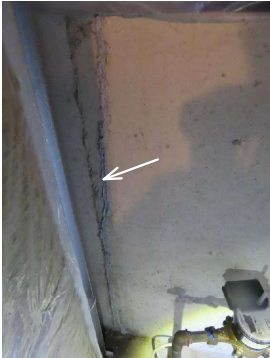
7. Utility Room Basement Walls: Covered with insulation, Concrete - **Repair worked noticed**

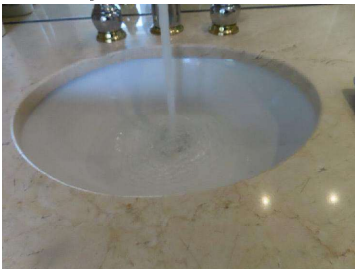
8. Primary Ensuite Bathroom Sink/Basin: Porcelain - **Drain slow or blocked**

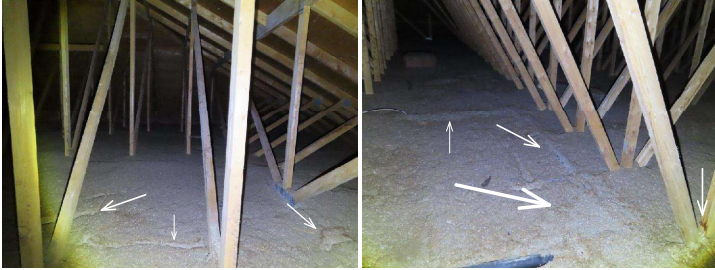
9. Inside bedroom closet Attic Insulation: Cellulose - **Insulation wetted**

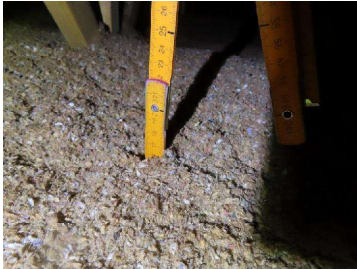
10. Inside bedroom closet Attic Insulation Value: R26 - **Recommend additional insulation be installed**

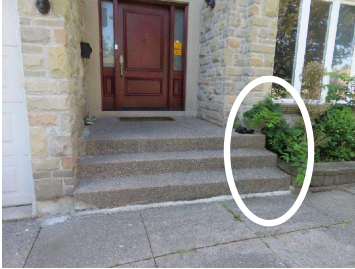
#### 1. Steps/Stoops: Concrete - Missing handrails

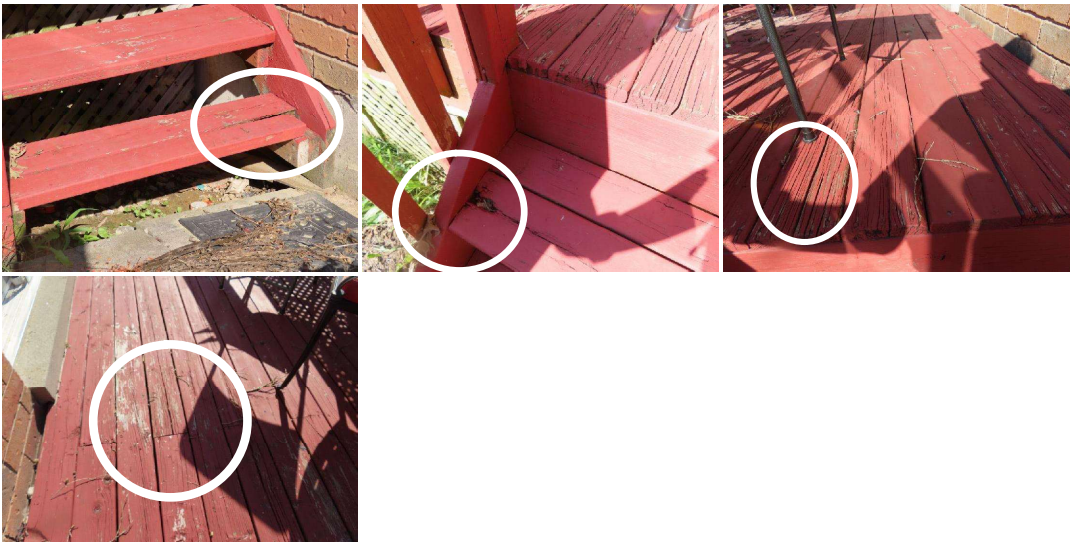
#### 2. Deck: Treated wood - Deck surface wood deteriorated, Staircase does not safe to use. It needs to rebuild.

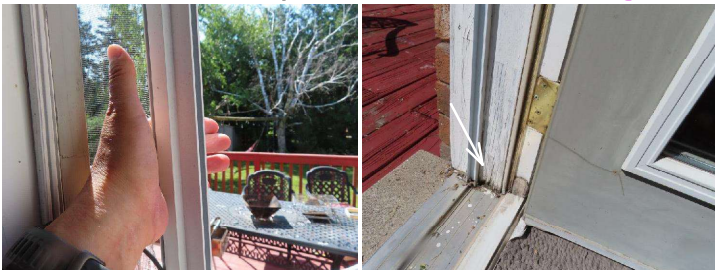
#### 3. Patio Door: Metal entry door - Screen door damaged, Frame damaged

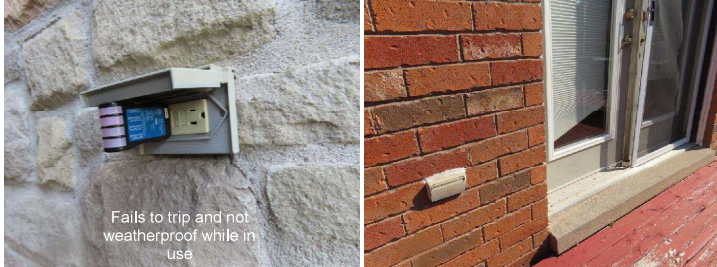
#### 4. Exterior Electric Outlets: 110 VAC GFCI - GFCI fails to trip or is miswired, Weather-resistant cover cannot protect while in use. It needs to replace

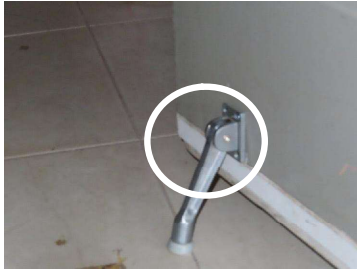
### 5. Front Garage Service Doors: Metal, Fire rated - Door stopper needs to remove

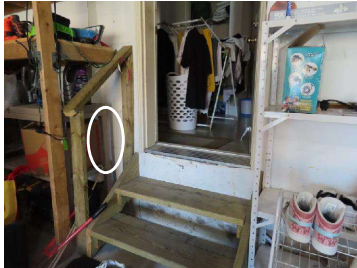
### 6. Front Garage Steps/Stoops: Wood - Missing guarding

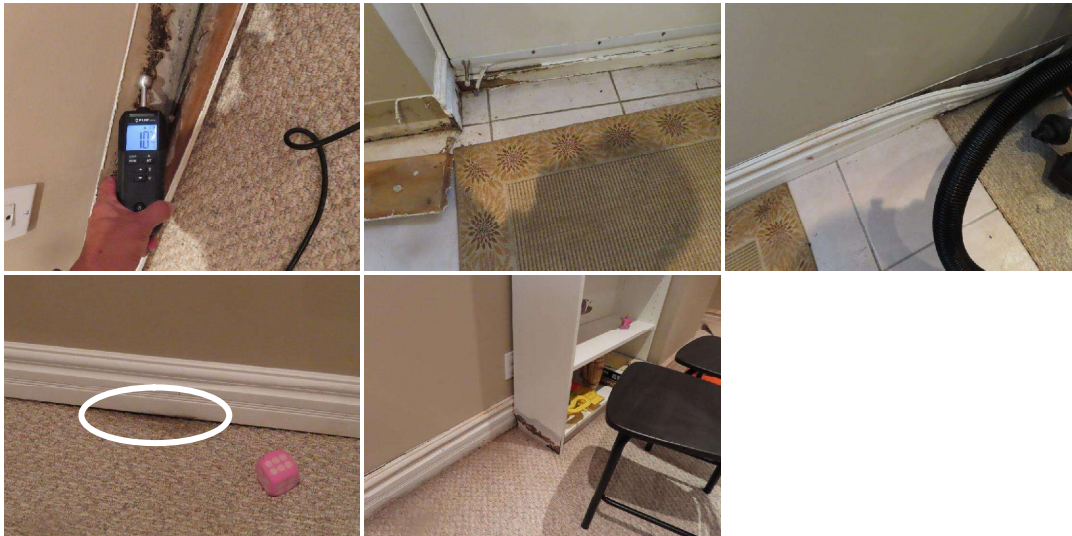
### 7. Main, Entertainment Room Basement Walls: Drywall with paint - Water damaged

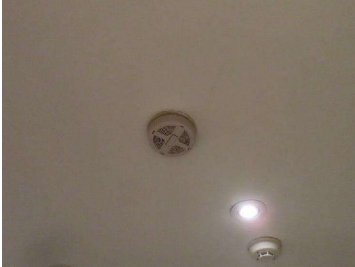
8. Main, Entertainment Room Basement Smoke Alarm: Present - Alarm installed at improper location, Smoke alarm at the end of lifetime

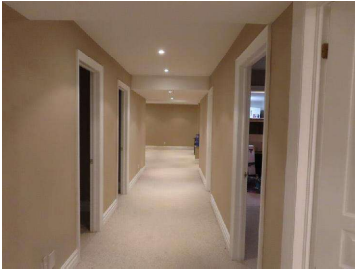
9. Main, Entertainment Room Basement Carbon Monoxide Alarm: None - CO alarms should be installed on every storey of the home. In multi-unit residential buildings, CO alarms are required whenever a fuel-burning appliance is present or when an attached garage shares a common wall, floor, or ceiling with a dwelling unit.

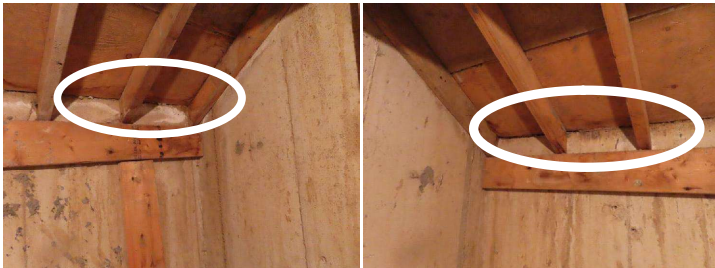
10. Cold Room Basement Walls: Concrete - Evidence of past or present water leakage

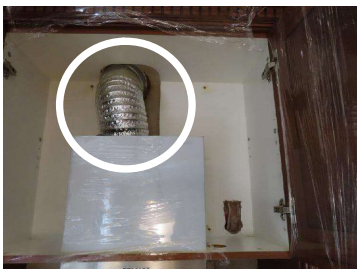
12. 1st Floor Kitchen Ventilator: Direct vent to exterior - Kitchen exhaust pipe is using improper material

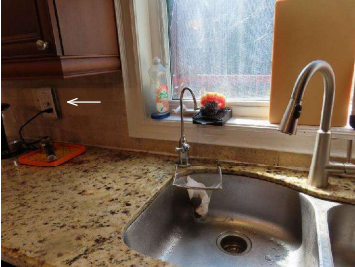
13. 1st Floor Kitchen Electrical: 110 VAC outlets and lighting circuits - **Non-GFCI circuit -recommend GFCI circuit be installed**

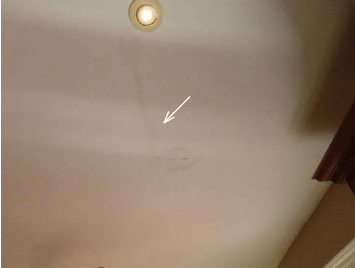
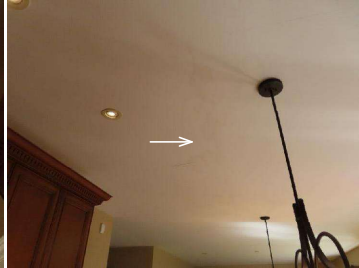
14. 1st Floor Kitchen Ceiling: Smooth - **Water stains present**

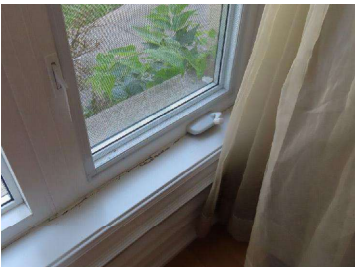
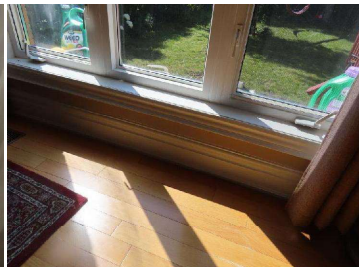
15. Family room, Dining room, Living room Living Space Windows: Vinyl casement - **Window too close to floor and can open more than 4 inches. This may fall children out of the window., Hard operation-needs improvements for ease of operation**

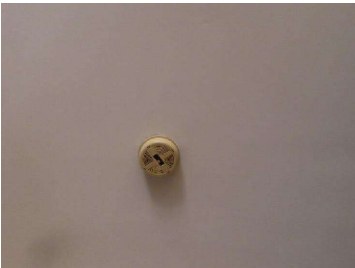
16. Family room, Dining room, Living room Living Space Smoke Alarm: Present - **Smoke alarm at the end of lifetime**

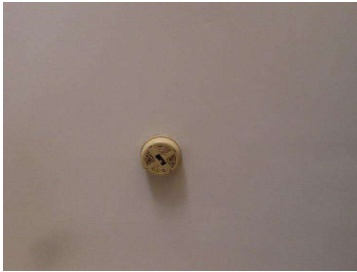
17. Family room, Dining room, Living room Living Space Carbon Monoxide Alarm: None - **CO alarms should be installed on every storey of the home. In multi-unit residential buildings, CO alarms are required whenever a fuel-burning appliance is present or when an attached garage shares a common wall, floor, or ceiling with a dwelling unit.**

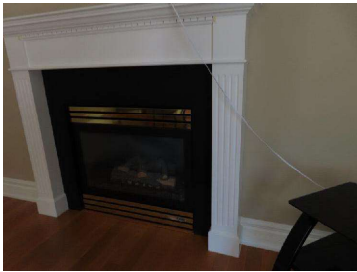
18. Family Room Fireplace Fireplace Construction: Prefab - **Fireplace did not operate.**

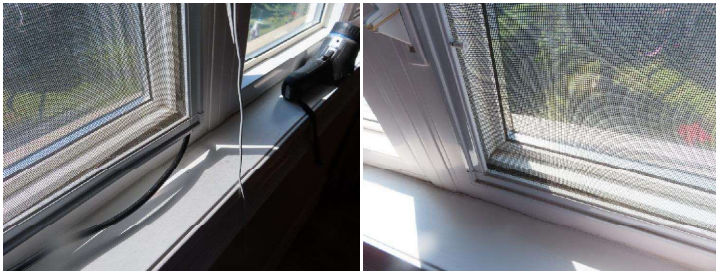
19. Primary Bedroom Windows: Vinyl casement - **Hard operation-needs improvements for ease of operation**

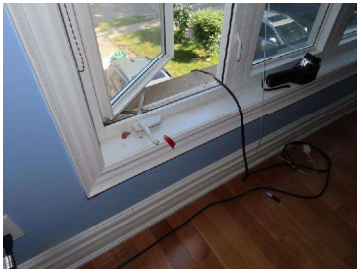
20. Front Left Bedroom Windows: Vinyl casement - **Window too close to floor and can open more than 4 inches. This may fall children out of the window.**

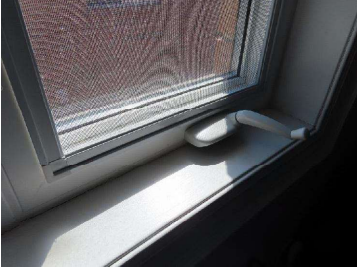
21. Middle Left Bedroom Windows: Vinyl casement - **Hard operation-needs improvements for ease of operation**

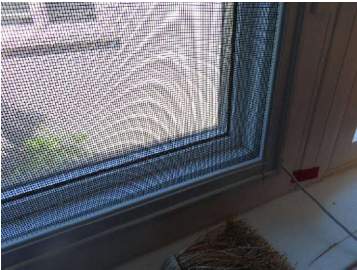
22. Middle Right Bedroom Windows: Vinyl casement - **Hard operation-needs improvements for ease of operation**

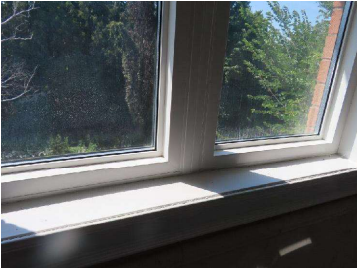
23. Primary Ensuite Bathroom Windows: Vinyl casement - **Moisture present inside the layers of glass**

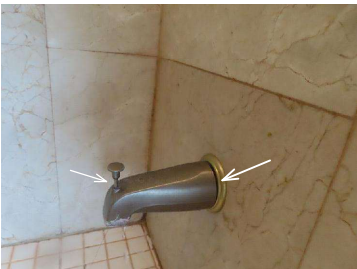
24. Primary Ensuite Bathroom Faucets/Traps: Fixtures with a PVC trap - **Shower diverter cannot switch, Shower diverter loose**

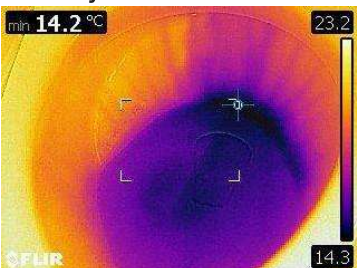
25. Primary Ensuite Bathroom Toilets: 1.5 Gallon Tank - **Water continues to run after flushing**

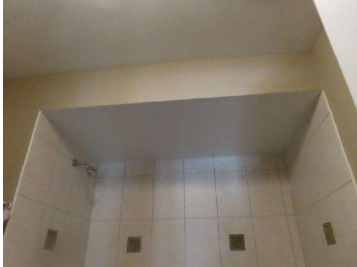
26. Middle Right Ensuite Bathroom Tub/Surround: Fiberglass tub and ceramic tile surround - **Shower curtain rod missing**

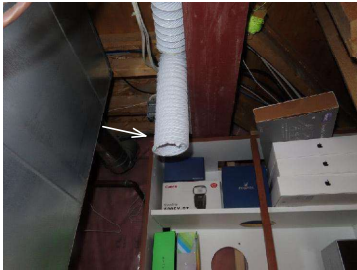
27. Basement Bathroom Ventilation: Electric ventilation fan and window - **Fan exhaust terminate inside basement**

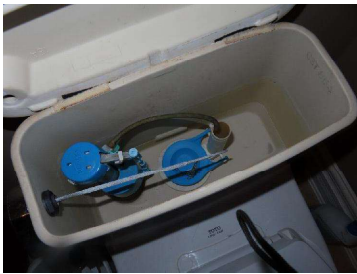
28. 1st Floor Half Bathroom Toilets: 1.5 Gallon Tank - **Toilet is inoperative**

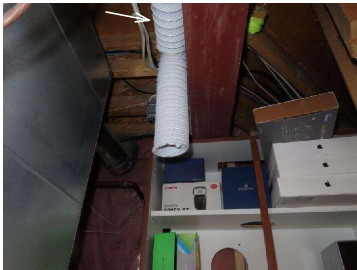
29. Basement Half Bathroom Ventilation: Electric ventilation fan - **Fan exhaust terminate inside basement**

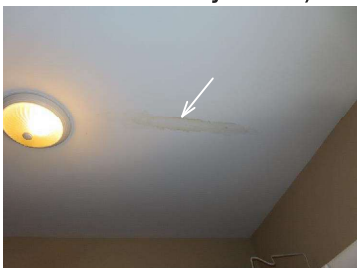
30. 1st Floor Laundry Room/Area Ceiling: Smooth - **Water stains present**

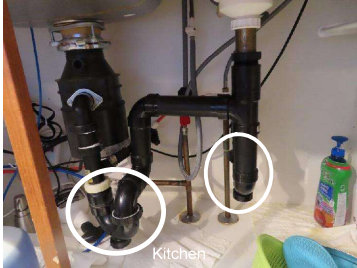
31. Drain Pipes: ABS - Double P trap installed

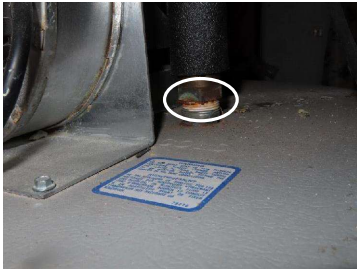
32. Basement Water Heater Water Heater Operation: Functional at time of inspection - Water heater design lifetime is in between 10 to 15 years, Water heater has exceeded design life, Water pipe rust

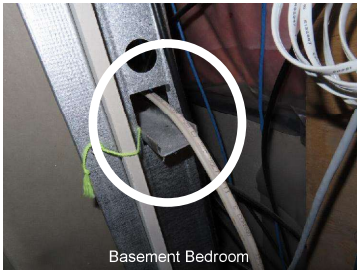
33. 120 VAC Branch Circuits: Copper - Missing grommet pass through steel stud

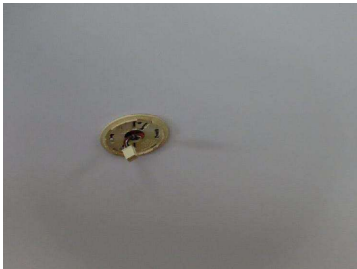
34. Smoke Alarms: Outside bed room(s) - Missing smoke alarm

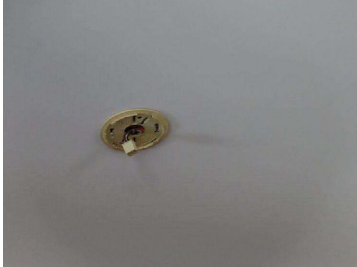
35. Carbon Monoxide Alarms: Outside bedrooms - CO alarms should be installed on every storey of the home. In multi-unit residential buildings, CO alarms are required whenever a fuel-burning appliance is present or when an attached garage shares a common wall, floor, or ceiling with a dwelling unit.
